REPORT NO. 96-59

MCALESTER ARMY AMMUNITION PLANT (MCAAP) WOODEN PALLET MIL-STD-1660 TESTS

- A. <u>BACKGROUND</u>. The U.S. Army Defense Ammunition Center and School (USADACS), Validation Engineering Division (SIOAC-DEV), was tasked by the U.S. Army Armament Research, Development and Engineering Center (ARDEC) to conduct MIL-STD-1660 tests on 40- by 48-inch oak pallets manufactured by McAlester Army Ammunition Plant (MCAAP).

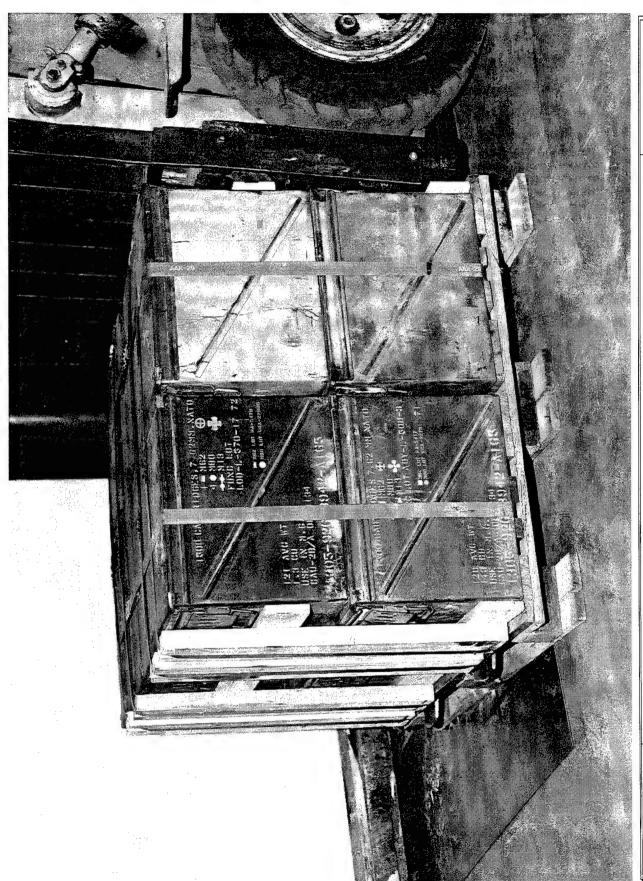
PALLET A

- A. <u>STACKING TEST</u>. The test sample was initially loaded to 22,300 pounds compression. The compression was released after one hour. No damage occurred.
- B. REPETITIVE SHOCK TEST. The duration of the test was 90 minutes for each orientation of the pallet. The transportation simulator was operated at 188 rpm for the longitudinal orientation of the pallet. At the completion of 90 minutes, one outside skid was completely free from the pallet. All three of the nails fastening the skid to two of the posts sheared off. The nails fastening the third post to the deck and stringer boards also sheared off. Instead of the three nails used to fasten the deck to the post at the other locations, only two nails were present at this joint. One of these nails entered the top of the post near the edge with its point extending out the side of the post.

C. <u>END OF TEST INSPECTION</u>. The outside skid that is still attached to the pallet appears to have the nails fastening the skid to the center post sheared off.

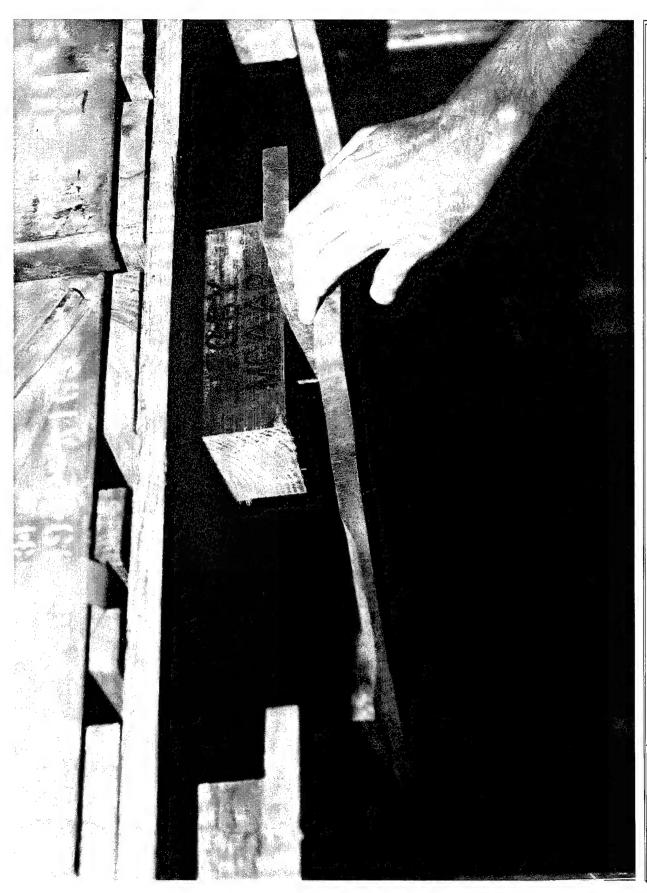
AO317-SCN-96-163-4104. This photo shows the detached skid of pallet A. Note the sheared nails in the skid.

- D. <u>CONCLUSION</u>. The pallets submitted failed to meet MIL-STD-1660 requirements. Nail failure occurred in each pallet during testing.
- E. <u>RECOMMENDATION</u>. Use nails that meet the specifications of MIL-P-15011.
